## **Sediment Profile Image Survey of the Lower Willamette River**

**Prepared for:**  
Lower Willamette Group

**Prepared by:**  
Striplin Environmental Associates, Inc.  
222 Kenyon Street NW  
Olympia, WA 98502

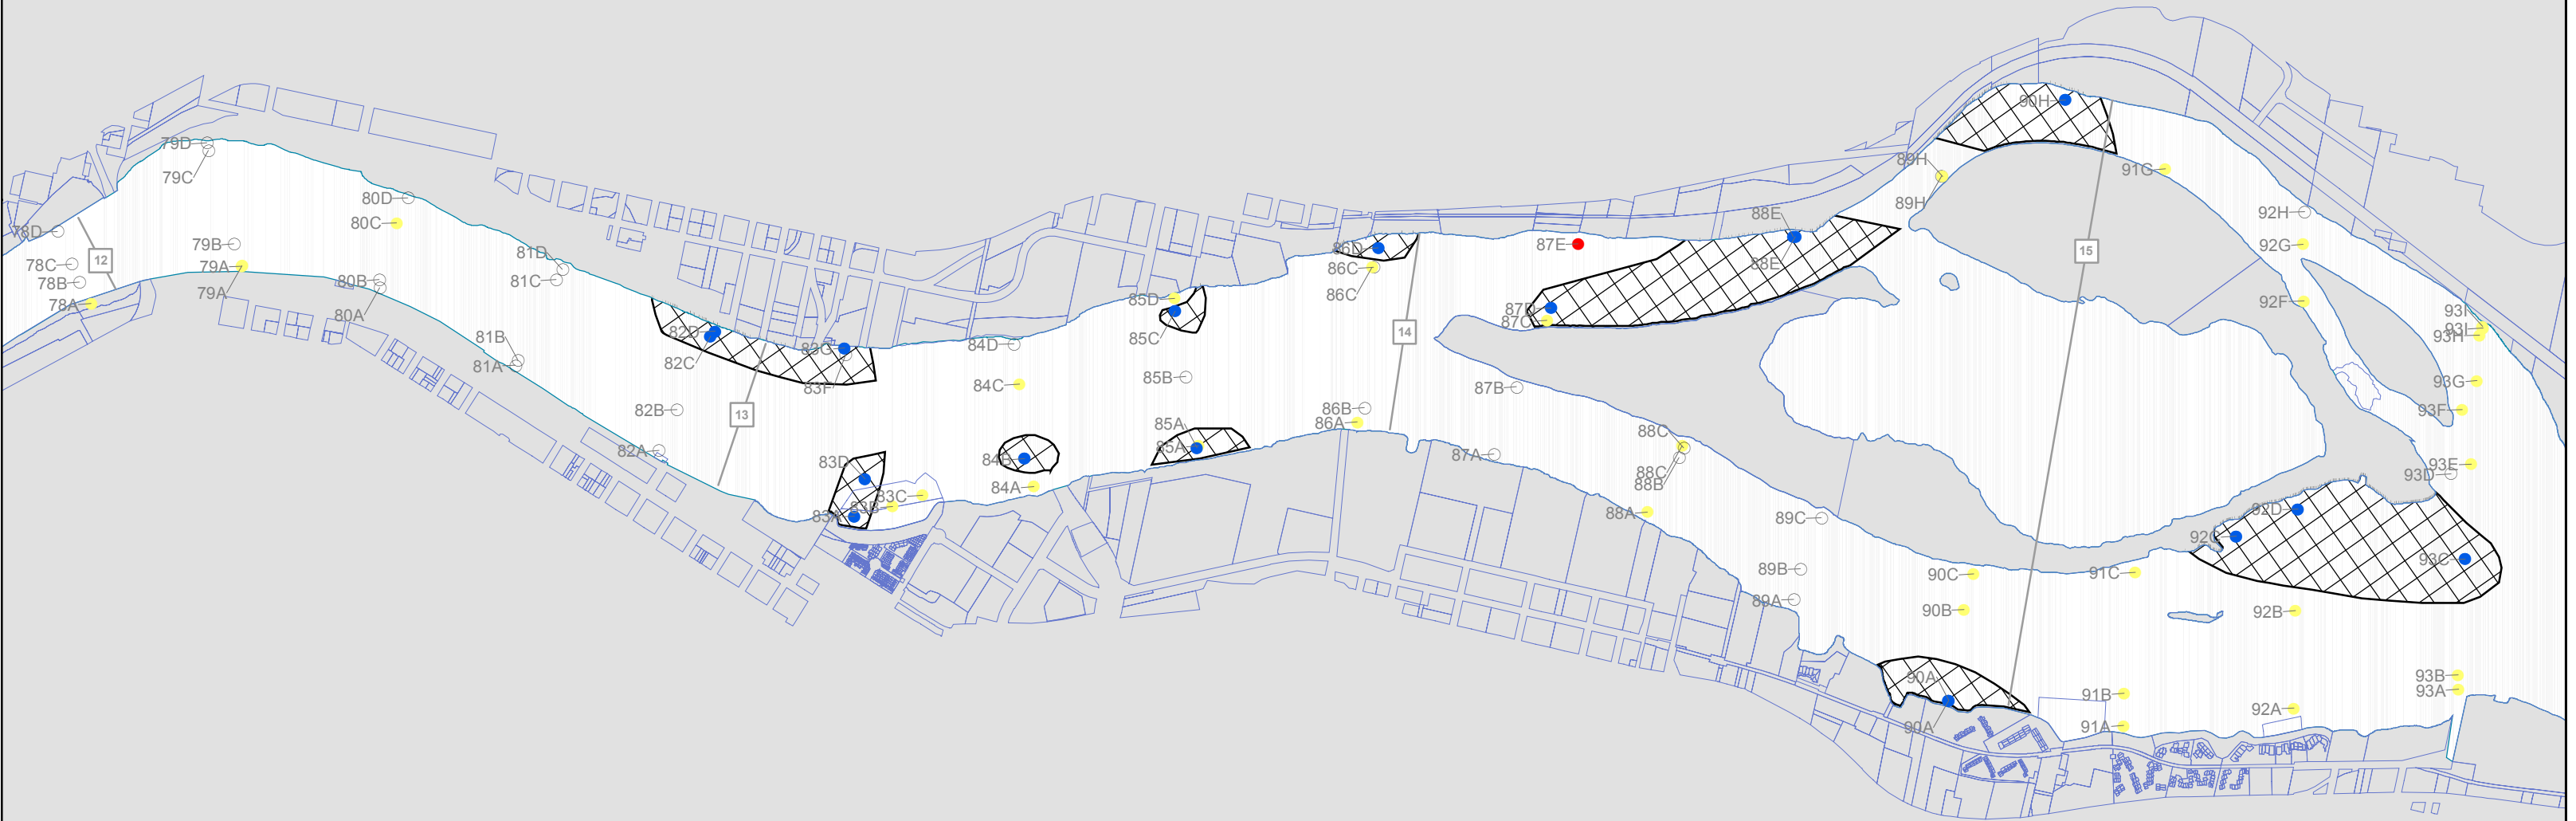
FIGURE 3-3d  
Sheet 4 of 4

The distribution of sedimentary methane in lower Willamette River sediments is presented in Figure 3-3d. Methane presence in the lower Willamette River is restricted to isolated areas. A small area that extends from the main channel to the eastern bank at RM 2.9 has methane present at very small quantities ( $< 1.5 \text{ cm}^2$ ). Other areas with methane were isolated one to two station clusters that were primarily located in the nearshore. The small, localized distributions and relatively low concentrations are noteworthy. The apparently lower methane production rates in sediments in the lower Willamette River (compared to upstream depositional areas) suggests lower downstream inputs of labile organic matter and/or higher sediment porewater mixing/flushing rates.

The distribution of infaunal successional stages in the lower Willamette River is presented in Figure 3-4d. The mile 3.0 to 1.1 segment is dominated by the presence of deep-dwelling, long-lived, Stage 3 infauna. SPI images showing Stage 3 infauna in the main channel and the nearshore environments are shown in Figures 3-23 and 3-24 (Stations 13C and 11A respectively). Stage 3 infauna were absent in the nearshore area at the confluence of the Willamette River and the Multnomah channel and in the main channel from RMs 2.3 to 1.5. Representative images showing only Stage 1 and 2 faunal assemblages are presented in Figures 3-23 and 3-24 (Stations 8D and 16A, in the channel and nearshore environments respectively).

measured RPD depths throughout the Portland Harbor river segment (RMs 9.7 to 3.0) are shown in Figures 3-2b through d. The distribution of methane is presented in Figures 3-3b through d, and the distribution of infaunal successional stages is presented in Figures 3-4b and 3-4d.

The distribution of sedimentary methane in lower Portland Harbor sediments is presented in Figures 3-3c and d. Methane was present primarily in sediments from nearshore depositional stations, although a few main channel stations also exhibited small amounts of sedimentary methane. Methane in the lower Portland Harbor sediment was more widespread than in the middle Portland Harbor, although less widespread than the upper Portland Harbor segment. Similarly, the magnitude of sedimentary methane in the lower Portland Harbor segment is intermediate between the middle and upper Portland Harbor segments. Representative SPI images showing sedimentary methane in the Lower Harbor are shown in Figures 3-20 and 3-22. Although sediments are methanogenic in this stretch, either the amount of organics deposited is less or there are higher porewater oxygen levels than in the Upper Portland Harbor.

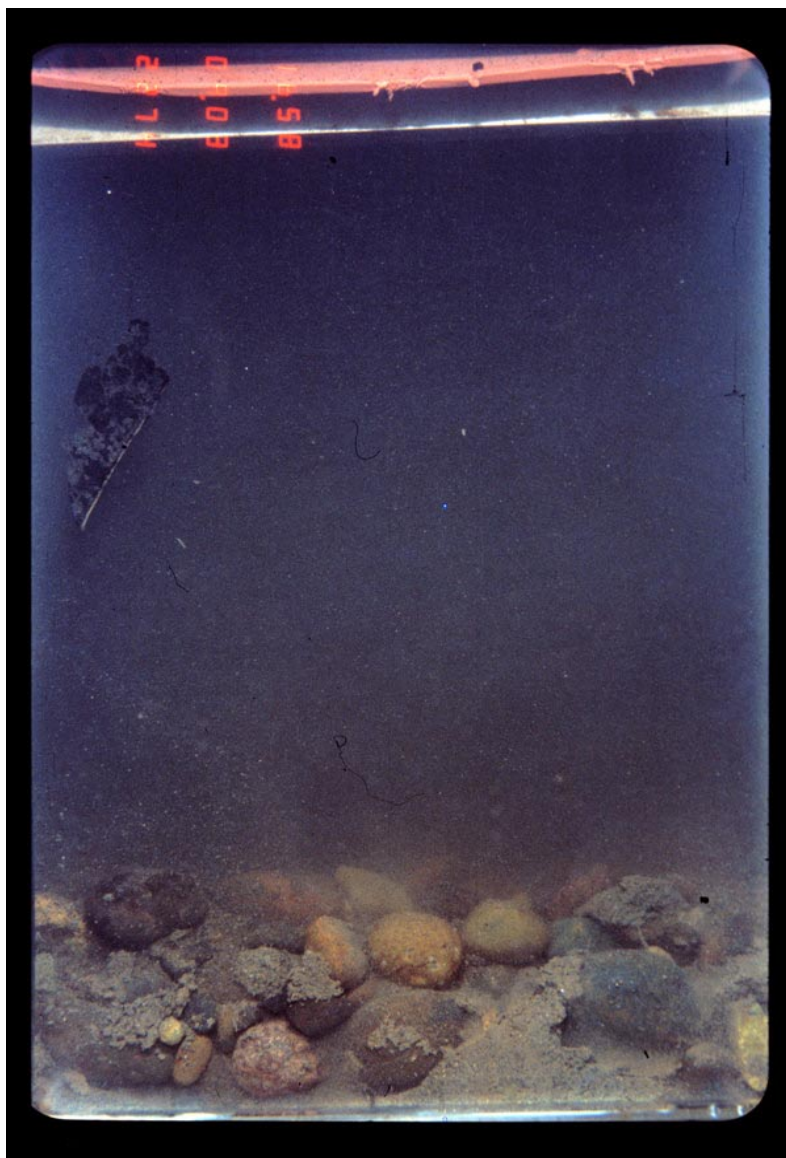
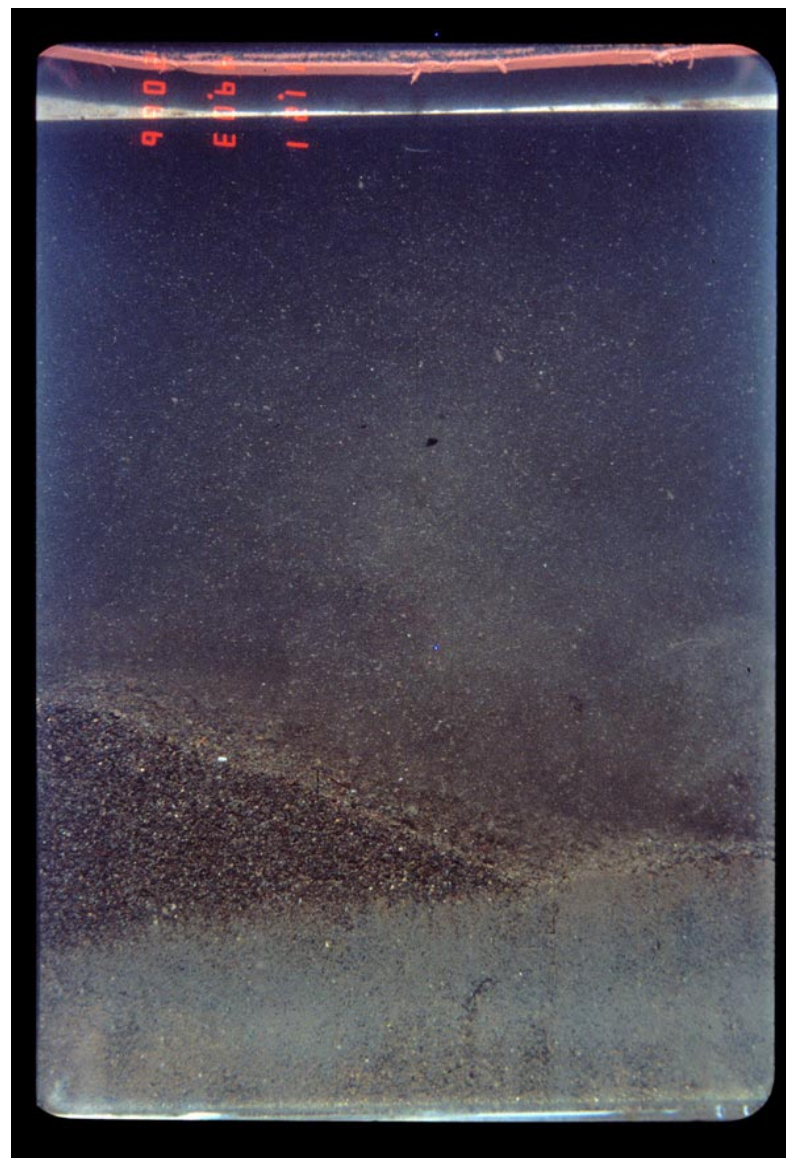
Figure 3-7. Representative SPI images from Stations 88B (left) and 80C (right), located in the main channel area of the upper surveyed area, illustrating the dynamic nature of the river from RM 15.7 to 11.

RIGHT: Station 80C is composed of transgressive, well-sorted fine to medium brown sand overlying and advancing over a poorly sorted gray, silty, fine sand.

Representative images from Stations 80C and 88B, located in the main channel from mile 15.7 to 11 segment, are shown in Figure 3-7. These images illustrate the coarse-grained sediments found within the main flow of the river. At Station 88B, the sediment was comprised of gravels with interstitial fine-grained sediment. Station 80C showed a migrating medium to coarse sand ripple over stiff silt. In both of these images, the sediment texture reflects the strong bottom

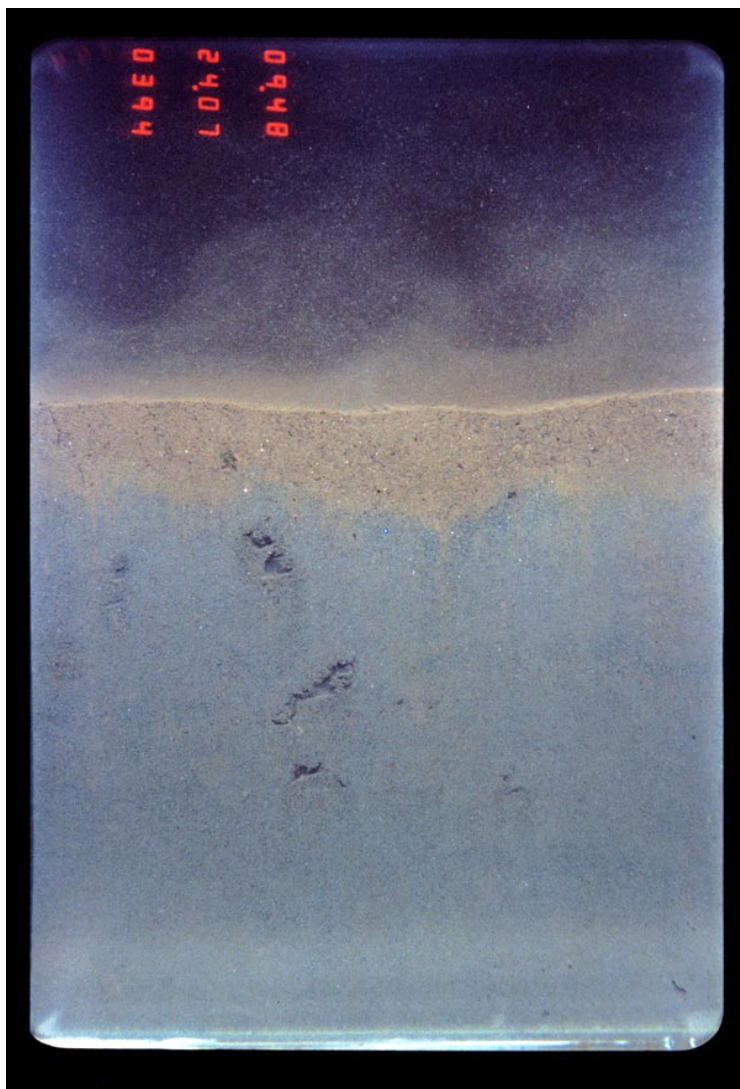
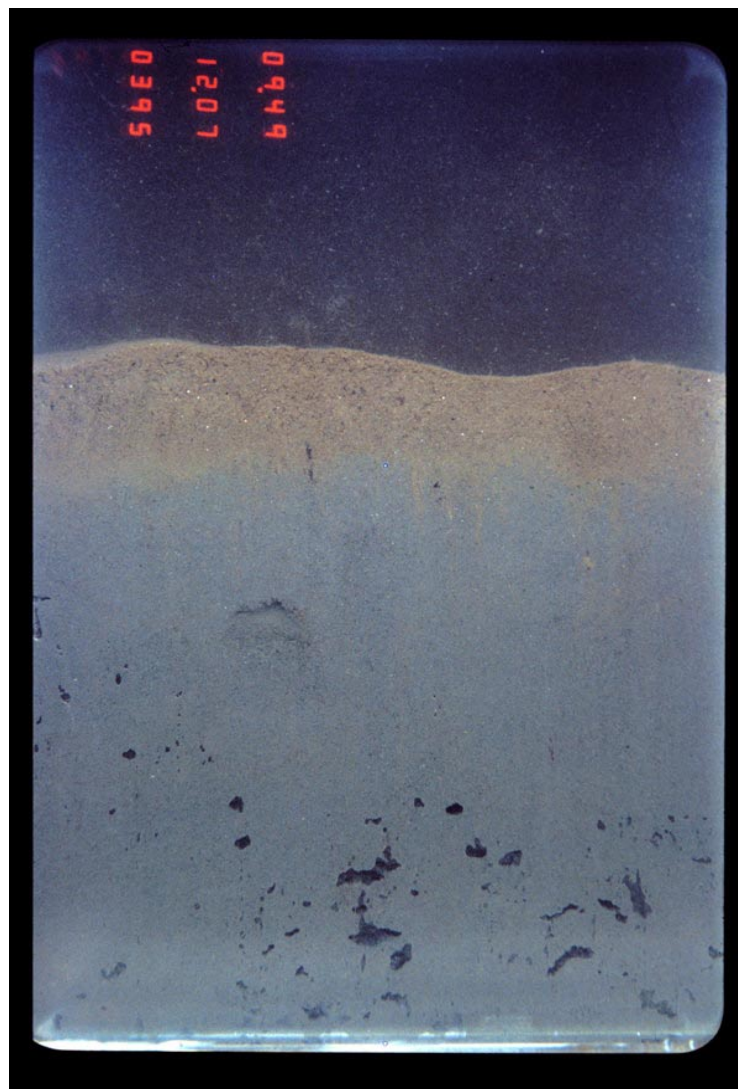
Figure 3-8. Representative SPI images from Station 90A, Replicate A (left) and replicate B (right), located in the nearshore area of the upper surveyed area. These images illustrate both the within station similarity and variability observed at depositional nearshore stations in the upper river.

RIGHT: This image also has gray, fine sandy silt with a prominent feeding void in left center of the frame. Fine worm tubes can be seen at the sediment-water interface, and numerous small methane pockets are present 4.8 cm below the sediment-water interface and extend to the bottom of the frame.

In the upper Willamette River, miles 15.7 to 11.0, *in-situ* sedimentary methane was observed only at five depositional nearshore stations (Figures 3-3a and b). Representative SPI images from Station 90A showing *in-situ* sedimentary methane are shown in Figure 3-8. The absence of methane from the main channel areas of the upper Willamette River was conspicuous. The coarse sediments found within the main channel apparently had a paucity of fine-grained sediment and organics, thereby precluding the generation of sedimentary methane.

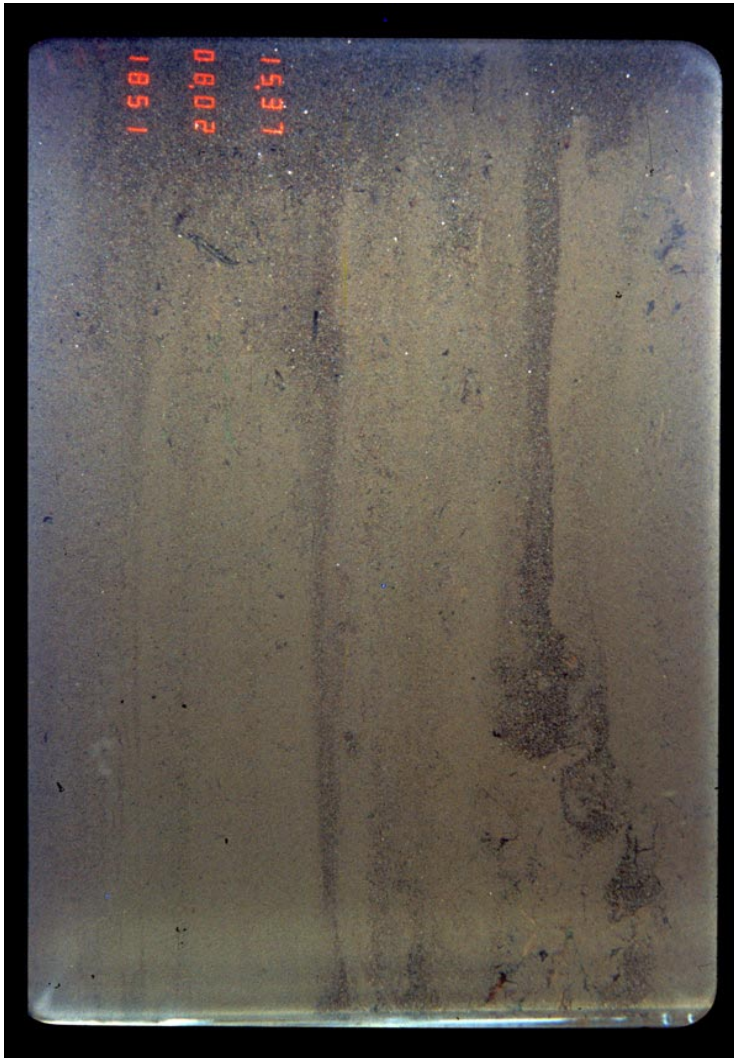
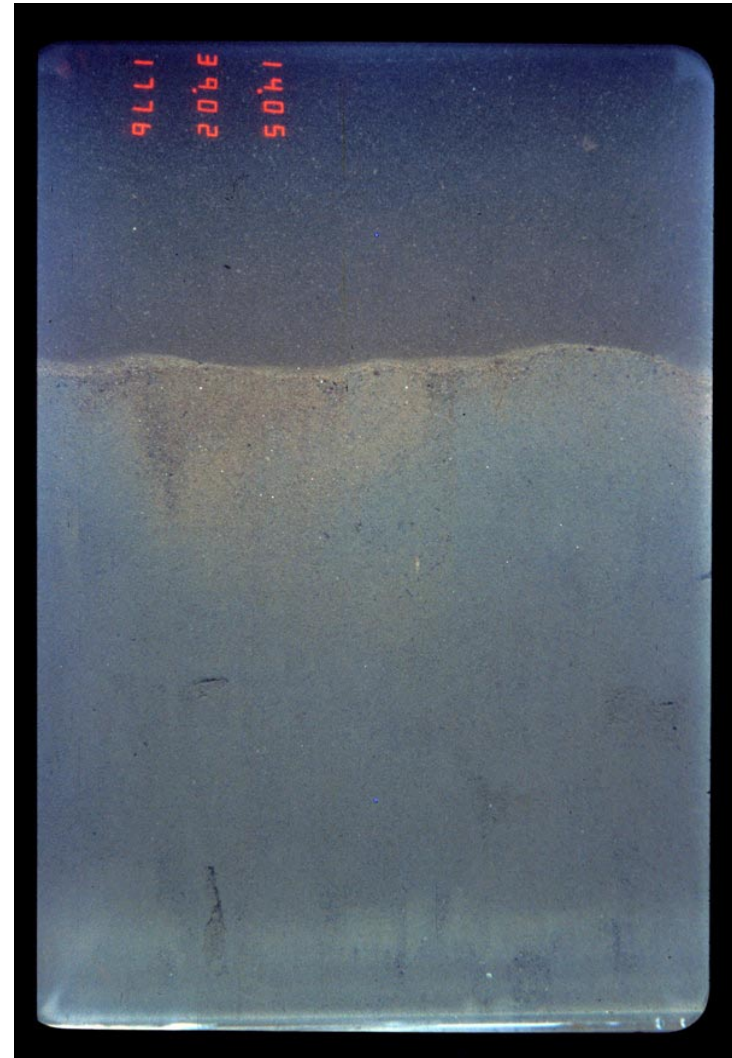
Figure 3-10. Representative SPI images from Stations 74B (left) and 71A (right), located in the main channel area of the 11.0 to 9.7 mile segment of the upper surveyed area and showing fine-grained sediments that have been deposited in the central channel of this river segment.

RIGHT: Station 71A is composed of gray, sandy silt with a thin RPD layer. There are active infaunal feeding voids at the right and left center of the frame from Stage 3 fauna. The RPD is thickest above left-center voids and physically controlled elsewhere. Although it appears to be depositional, this station does not experience the magnitude and rapidity of deposition observed at Station 74B.

The distribution of infaunal successional stages in the 11.0 to 9.7 mile segment of the upper Willamette River is shown in Figure 3-4b. The main difference between this and the upstream segment was that Stage 3 infauna were present in main channel sediments from Transect 72 (RM 10.5) to Transect 70 (RM 9.7). It has been noted previously that this area was largely depositional and characterized by soft silts with thick oxidized surface layers. Suitable habitat for Stage 3 infauna (soft silts and/or sandy sediment without constant physical disturbance) was not present in the upper survey area until this portion of the river. Images from the main channel showing Stage 3 infauna are presented Figure 3-10.

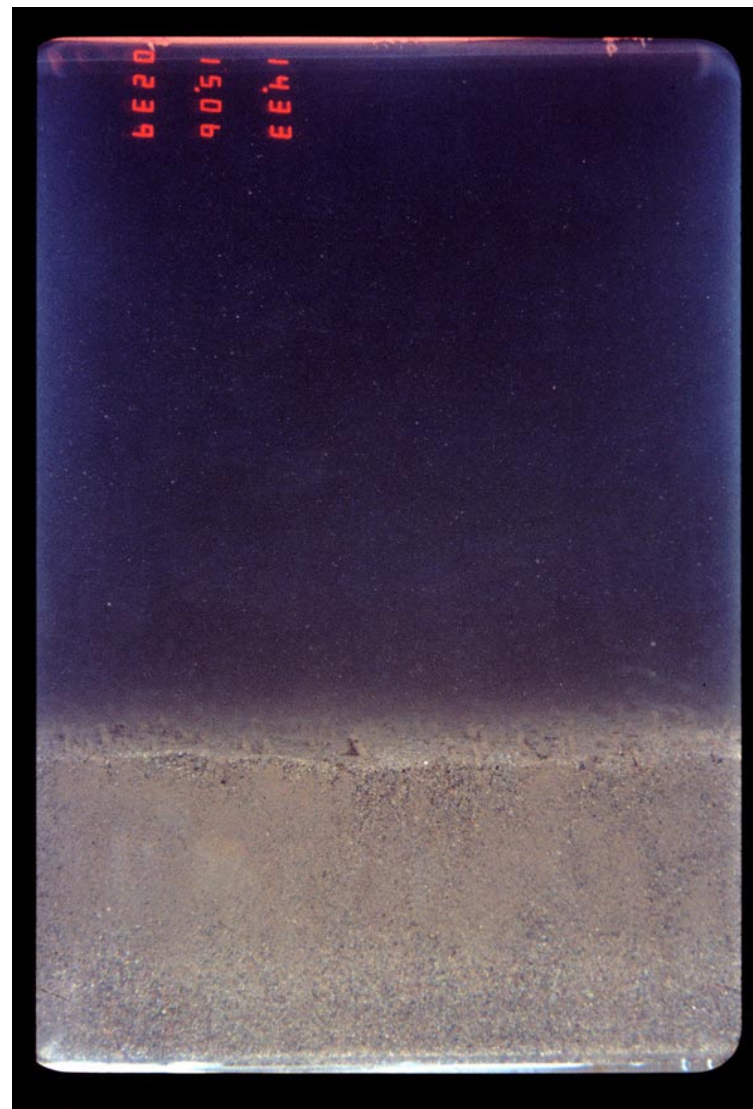
Figure 3-25. Representative SPI images from Stations 3D (left) and 1D (right), located in the main channel areas of the 1.1 to 0 mile segment of the lower Willamette River.

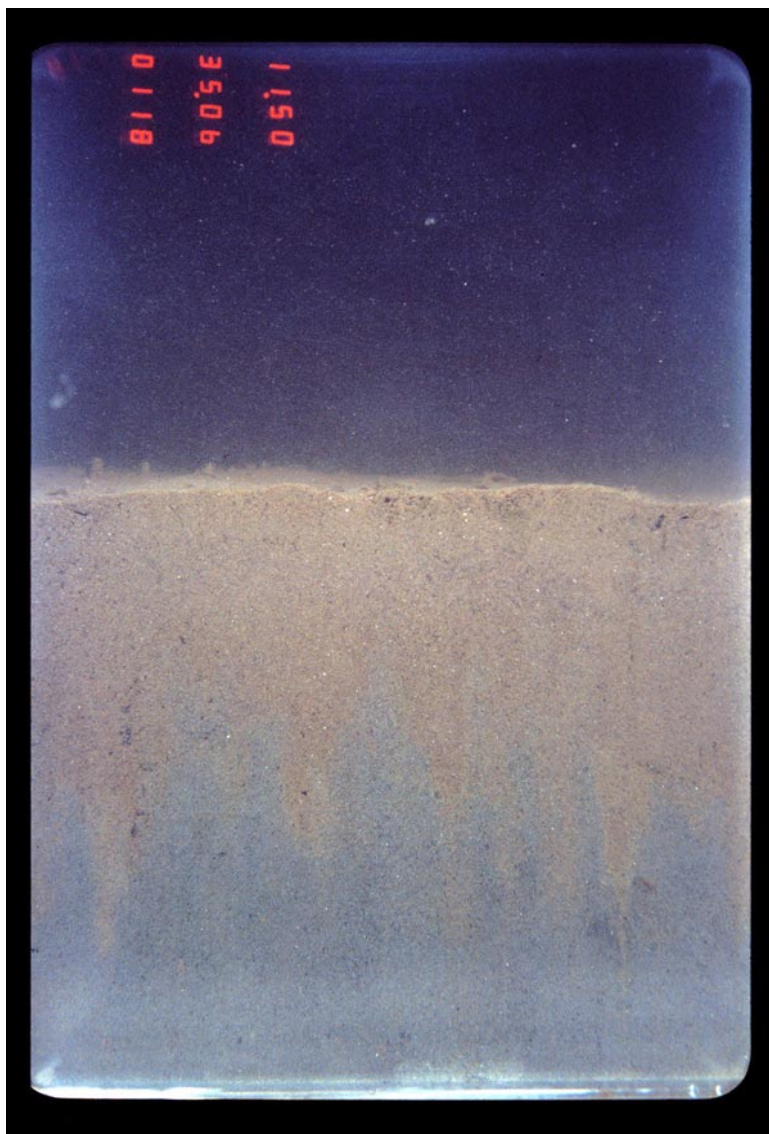
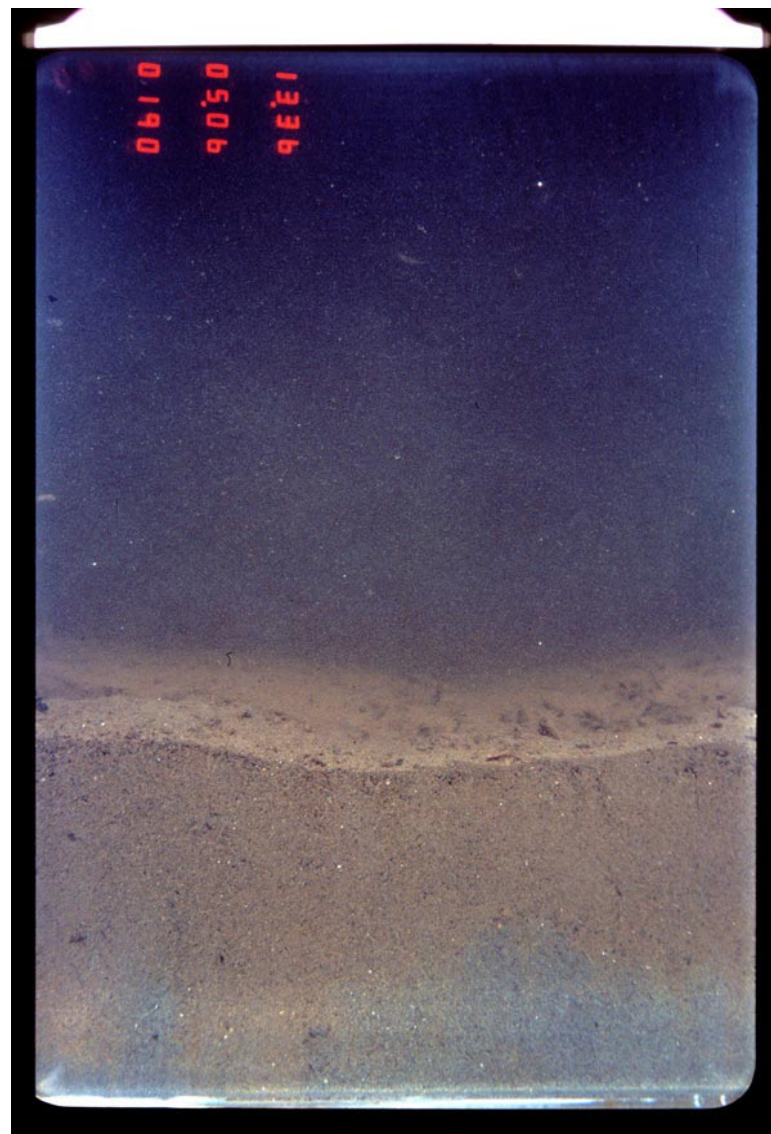
Figure 3-26. Representative SPI images from Stations 4A (left) and 2A (right), located in the nearshore areas of the 1.1 to 0 mile segment of the lower Willamette River.
